Screening Site Inspection
Final Report

Remline (a.k.a. Model Industries) Site
ILD 005 112 420
April 1997

Prepared for:
U.S. Environmental Protection Agency
Contract 68-W8-0064
Work Assignment 29-5JZZ

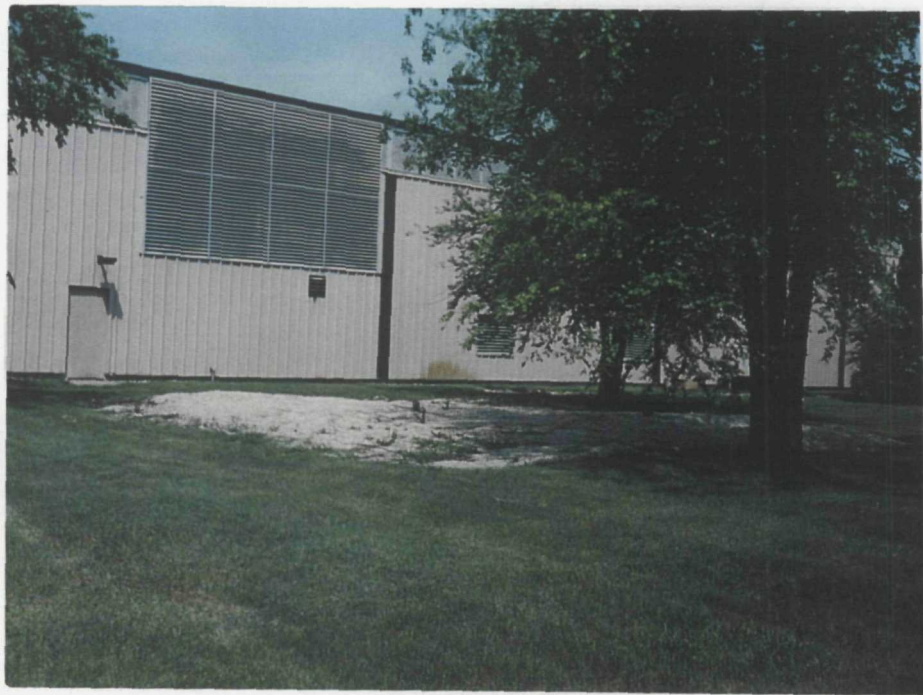
Description: Sewage ejector system.

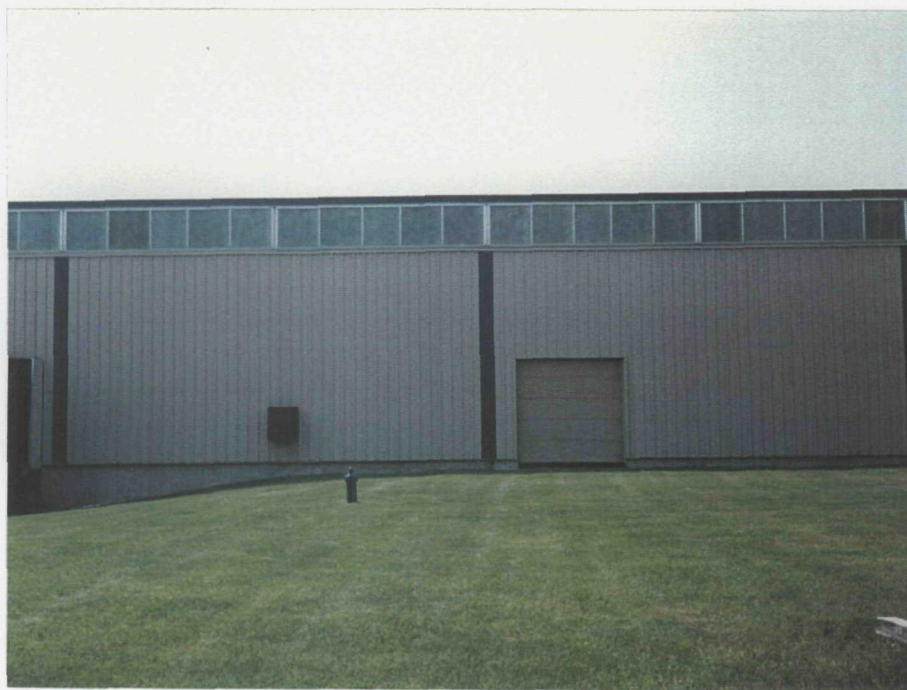
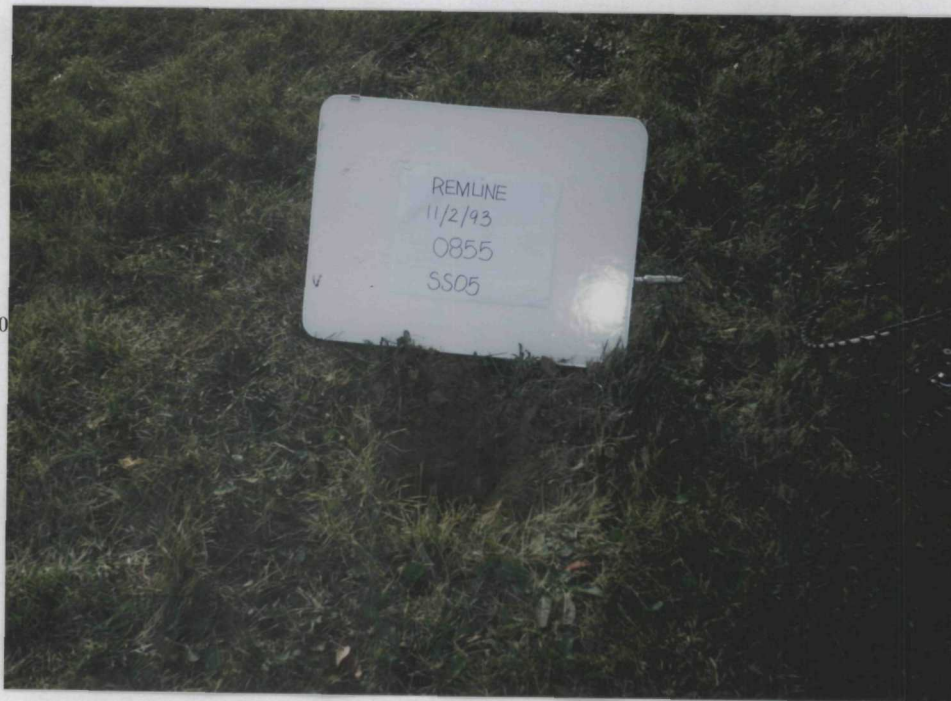
Soil sample SS05 was collected from near the former drum staging pad, located near the southwestern corner of the facility parking lot. The sample location was measured from the southeastern corner of the pad, at 5'9" directly southeast.

Description: Soil sample location SS05.

Description: Expanded view of soil sample location SS05.

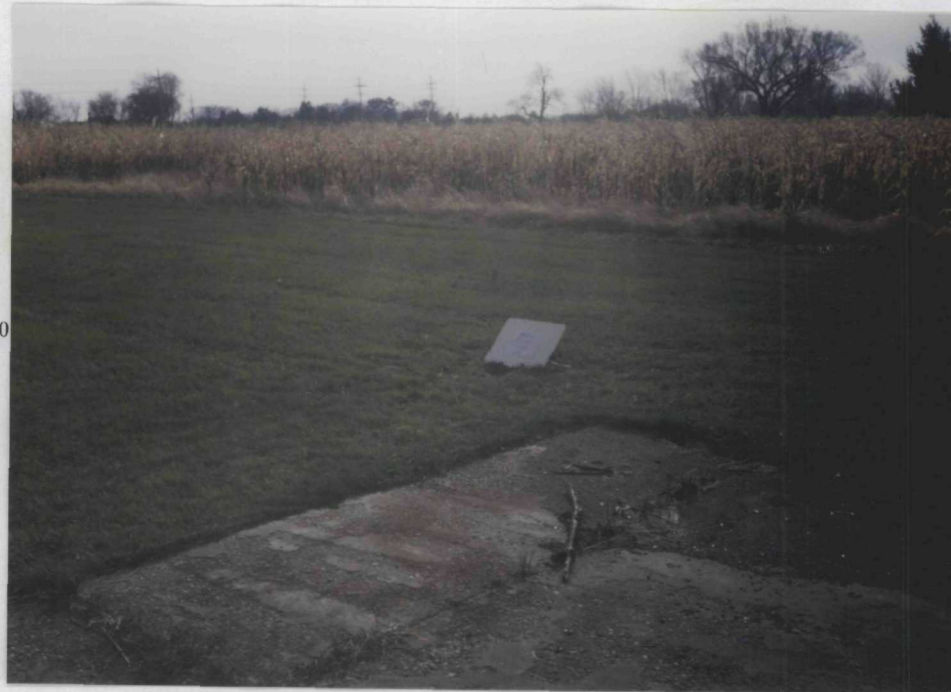
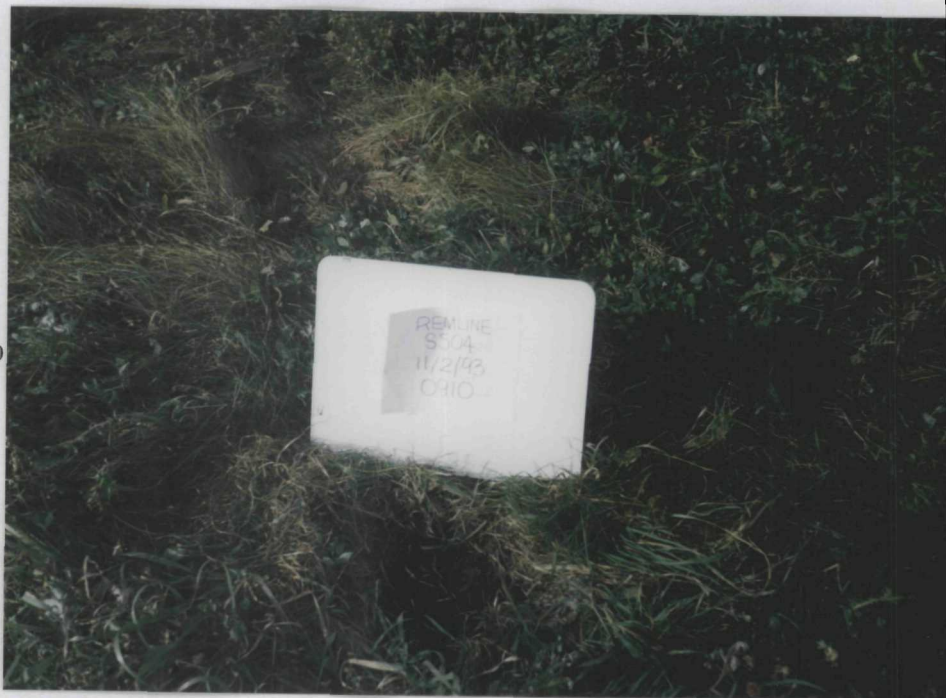
Soil sample SS04 was collected from what is presumed to be the former buried drum area. The sample location was measured from the southern corner of the facility parking lot at 13' north and 89'2" west.

Description: Soil sample location SS04.

Description: Expanded view of soil sample location SS04.

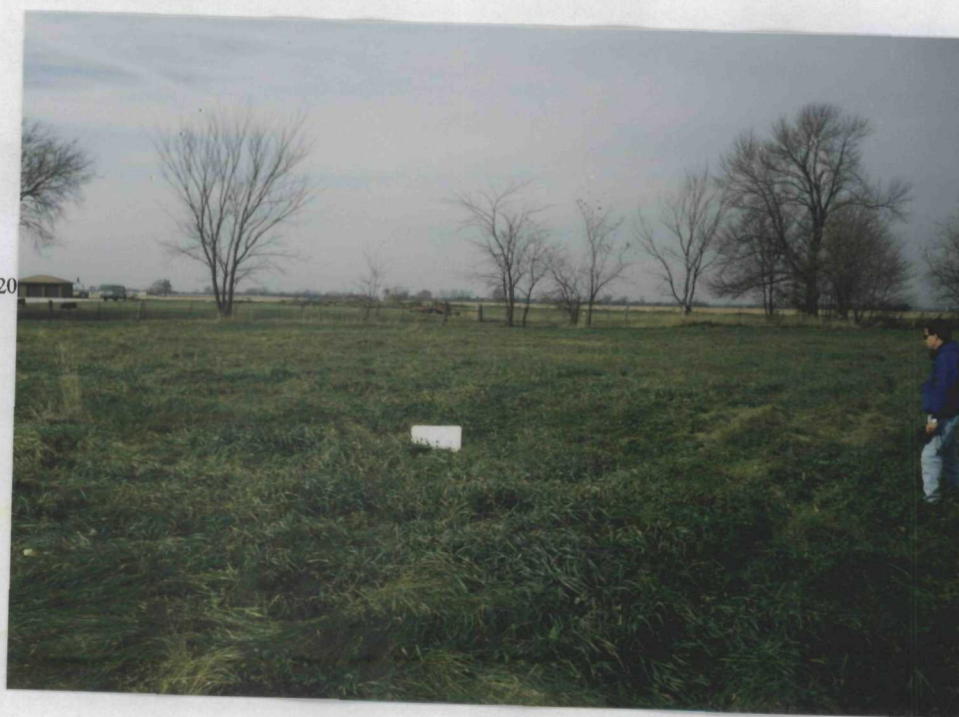
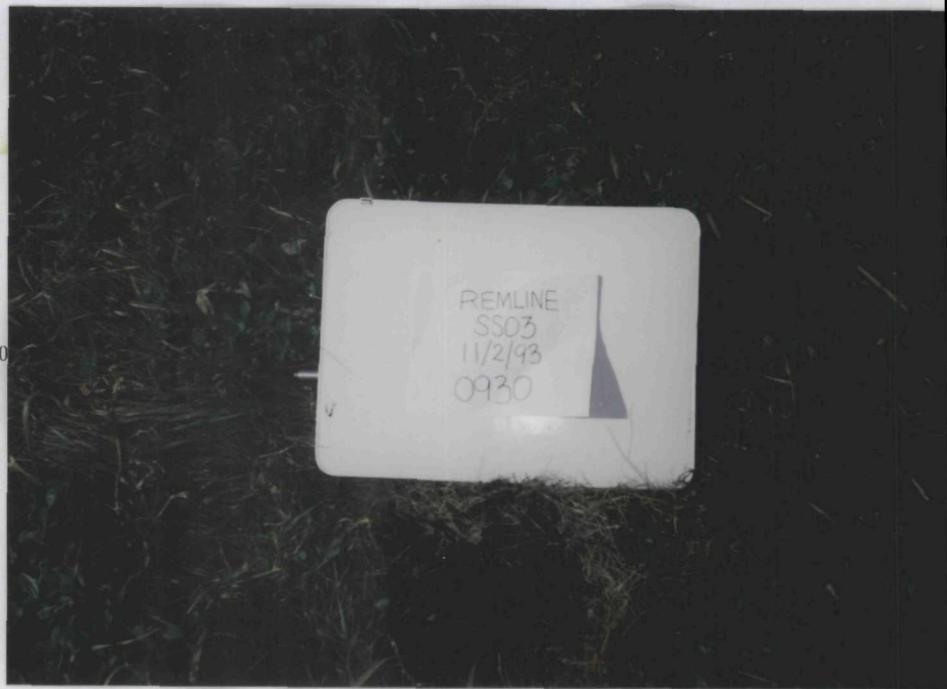
Soil sample SS03 was collected from what is presumed to be the southern end of the septic field. The sample location was measured from the southern edge of a loading dock road at 23'2" south and 39'3" west.

Description: Soil sample location SS03.

Description: Expanded view of soil sample location SS03.

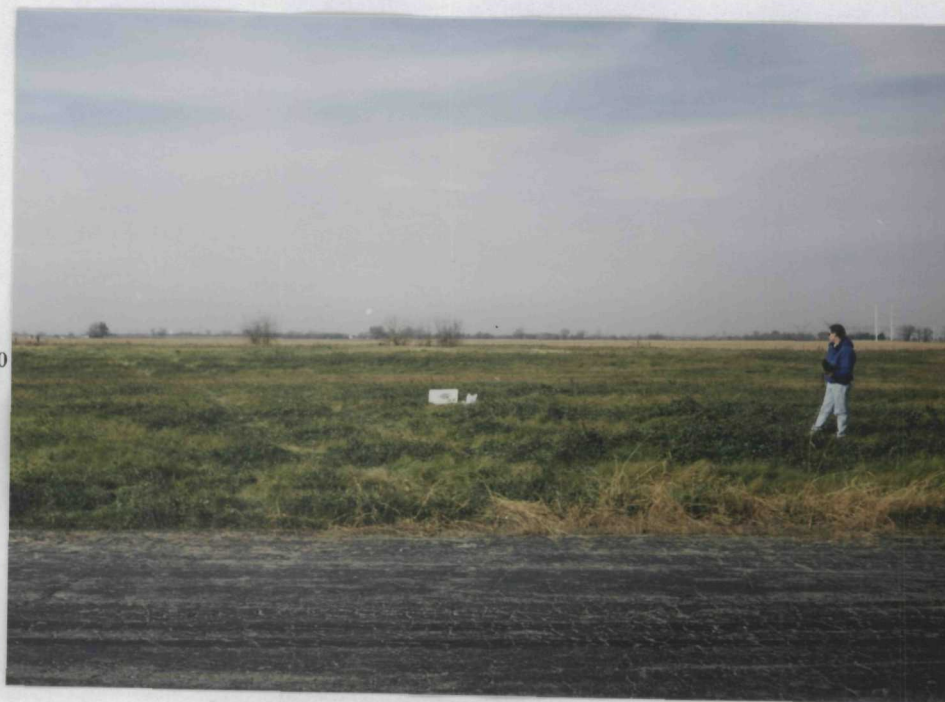
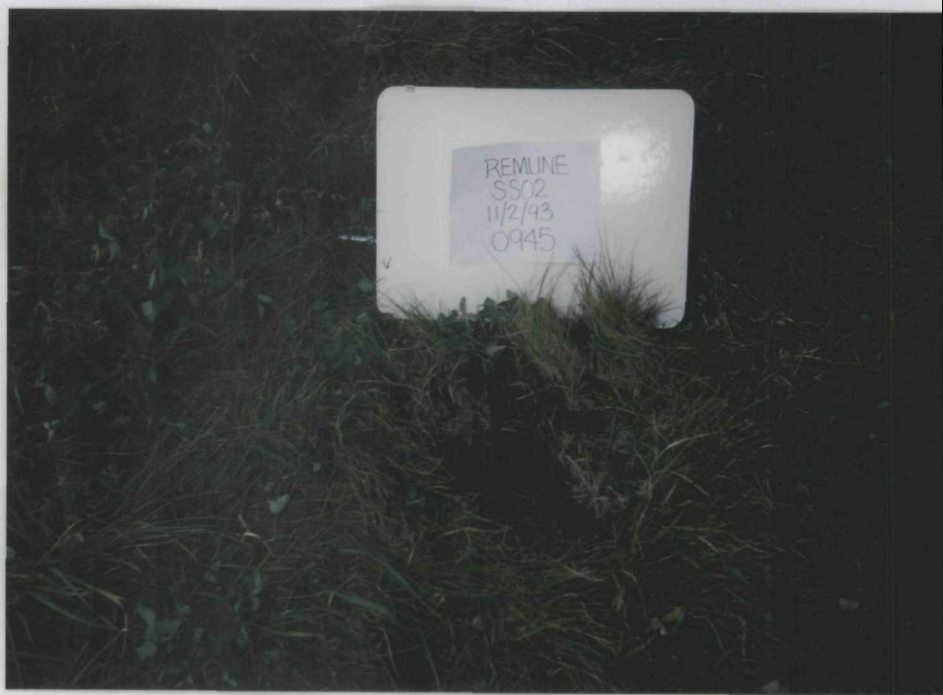
Soil sample SS02 was collected from what is presumed to be the northern end of the septic field. The sample location was measured from the southern end of the loading dock at 13'7" north and 43'7" west.

Description: Soil sample location SS02.

Description: Expanded view of soil sample location SS02.

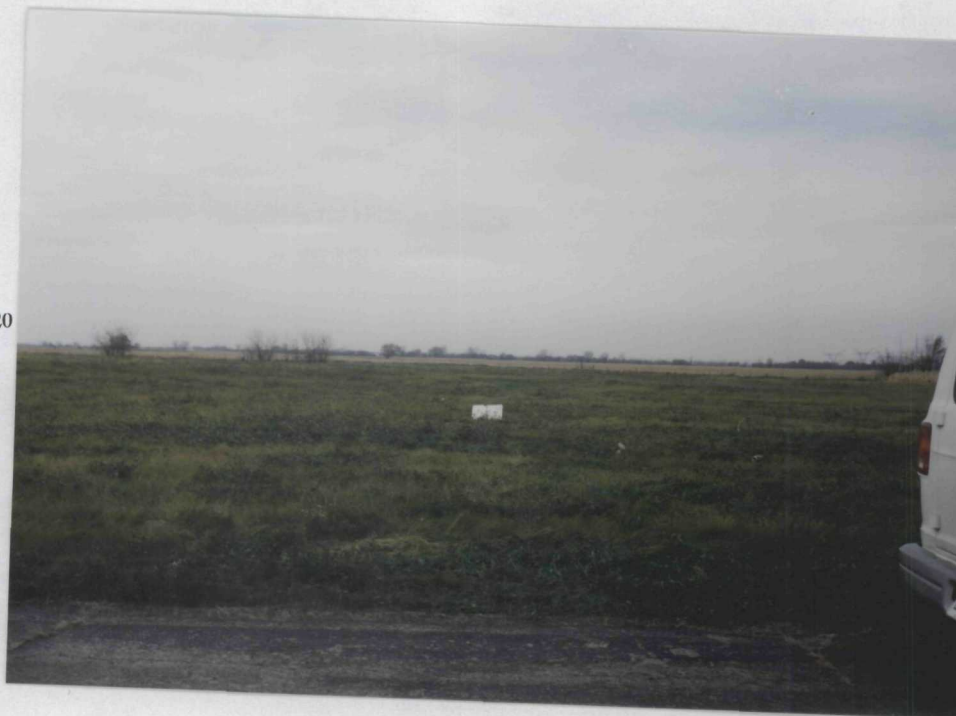
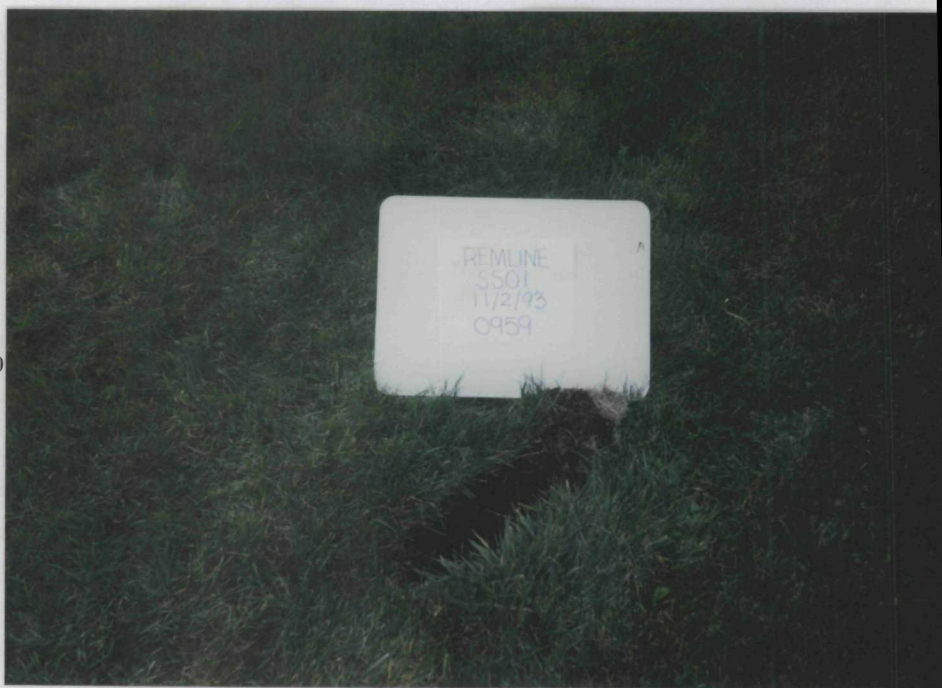
Soil samples were labeled SS01 through SS06. Soil sample SS01 was designated as the background sample and was collected offsite, north of the Remline site, approximately 88 feet and 8 inches north of the Remline entrance drive and 66 feet and 3 inches west of Route 47. This sample location was selected as representative of soil conditions in the area.

Description: Soil sample location SS01;
background sample.

Description: Expanded view of soil sample
location SS01.

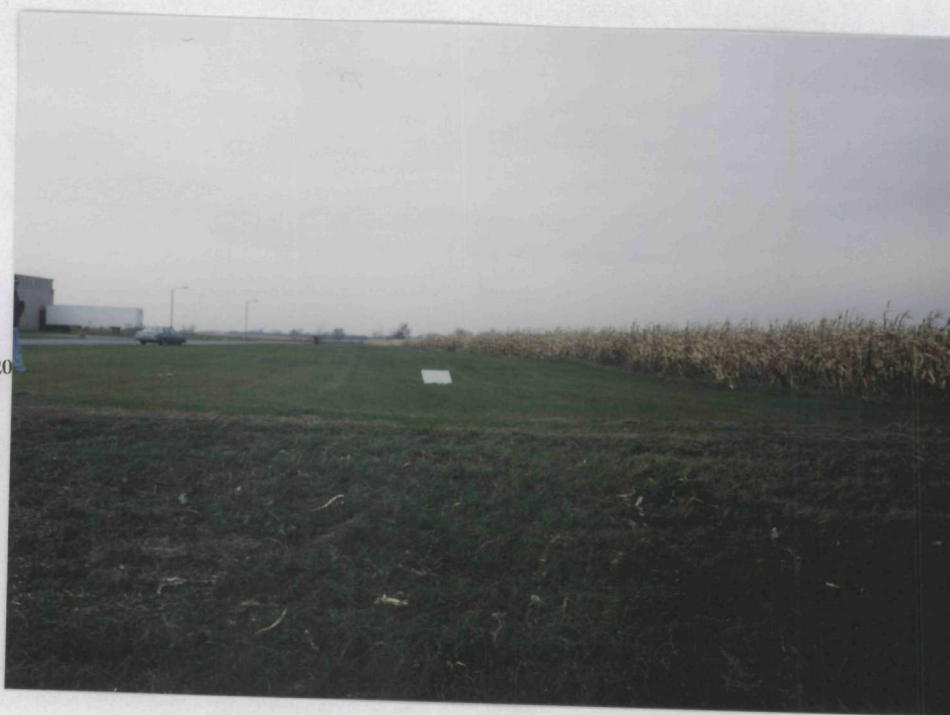
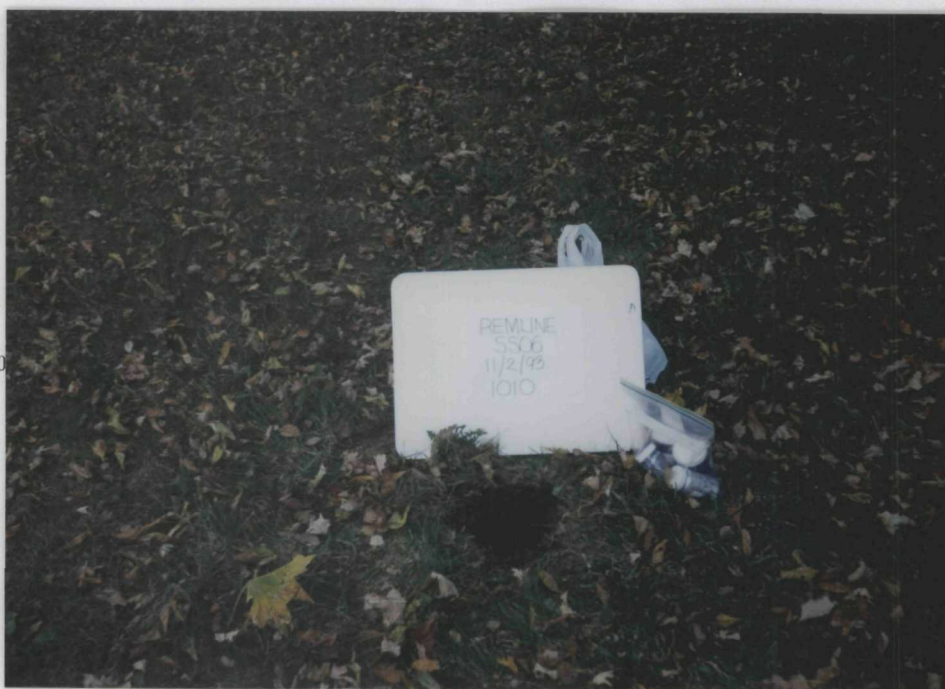
Soil sample SS06 was collected from what is presumed to be the former UST location. The sample location was measured from the corner of the Remline facility office/entrance at 138' north and from the eastern side of the Remline facility at 42' east.

Description: Soil sample location SS06.

Description: Expanded view of soil sample location SS06.

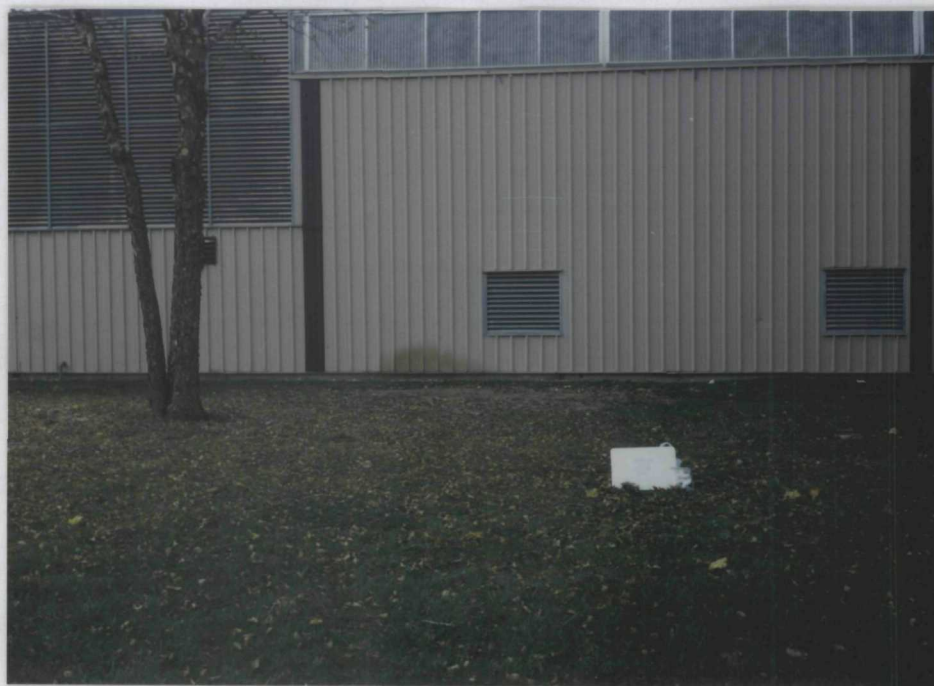
RW02 and RW03 were collected from onsite production/drinking water wells at the Remline site. The RW02 well is located at the northern end of the site and serves as a backup well for the facility. The RW03 well is located at the southern end of the site and serves as the main well for the facility. The tap at RW02 was inaccessible, and the sample was collected using a garden hose. The water was run for more than fifteen minutes. RW03 was collected directly from a sink tap in a supply room.

Description: Drinking/production well sample location RW03.

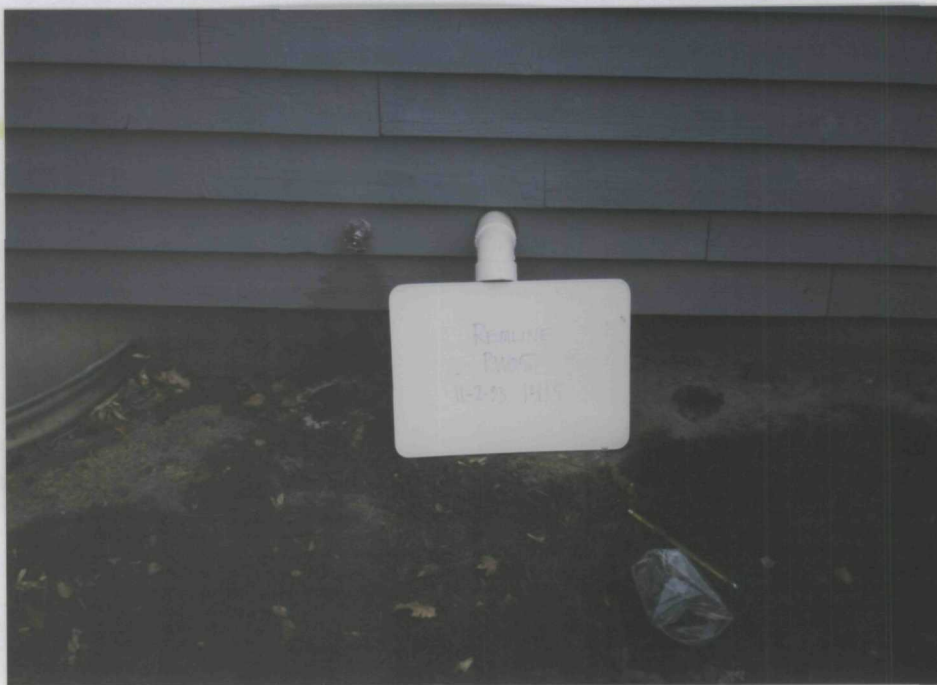
RW06 was collected from a shallow residential well located approximately 1/2 mile south of the site. A slight sulphur odor was noted during sample collection. RW06 is presumed to be downgradient of the Remline site. Efforts to locate a background shallow well have been unsuccessful; however, nearby shallow wells promote a concern and RW06 was sampled to verify if a concern exists.

Description: Residential well sample location
RW06.

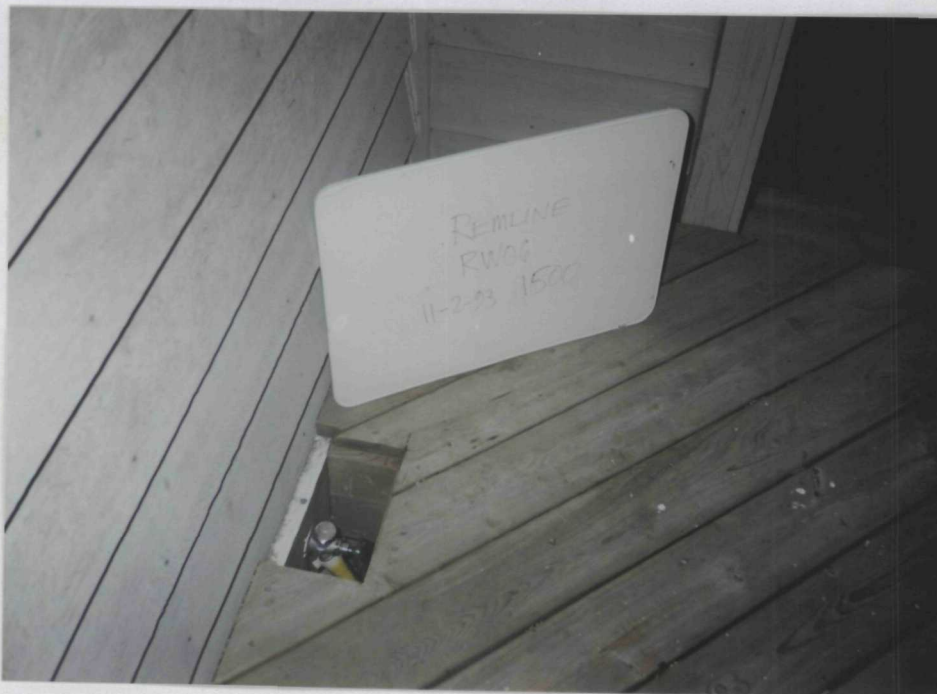
Sample RW04 was collected from a residential well located approximately 1/8 mile southwest of the Remline site. A sulphur odor was noted during sample collection. RW04 is presumed to be downgradient of the Remline site.

Description: Residential well sample location
RW04.

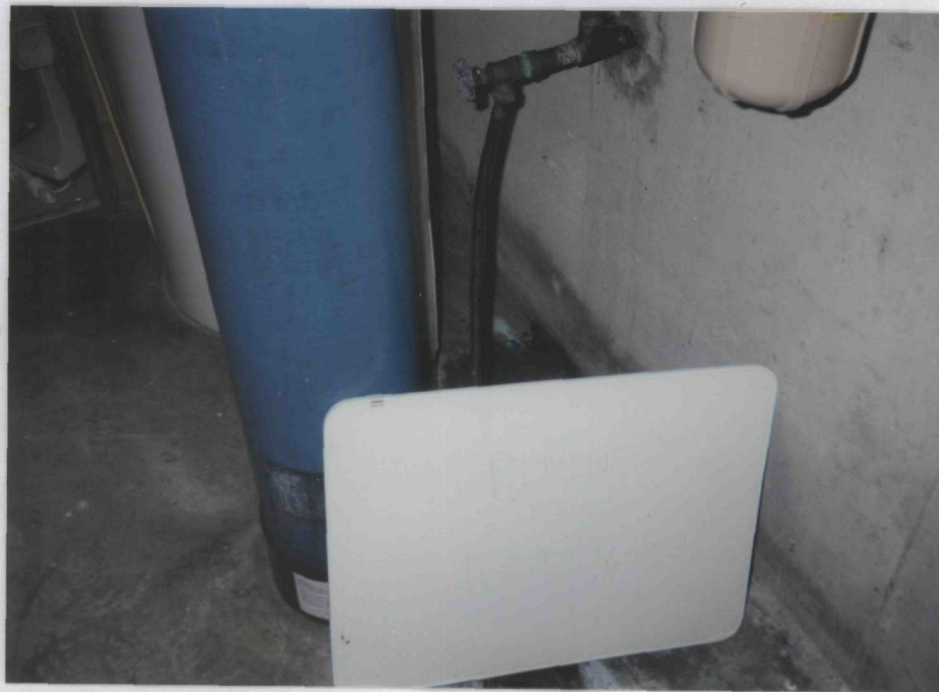
Drinking water sample RW01 was designated the background sample and was collected from a residential well approximately one mile northwest of the Remline site. This sample location was selected as representative of groundwater conditions in the area and is assumed upgradient.

Description: Residential well sample location
RW01.
